US Army Corps
of Engineers®

Periodic Inspections of Coastal Structures with Stone Armor

PURPOSE: This Coastal and Hydraulics Engineering Technical Note (CHETN) provides information on the long-term structural performance of selected stone-armored navigation structures to their environment. Coastal structures at St. Paul Harbor, AK, and Burns Harbor, IN, are discussed herein. The response of concrete-armored coastal structures to their environment will be presented in a subsequent CHETN.

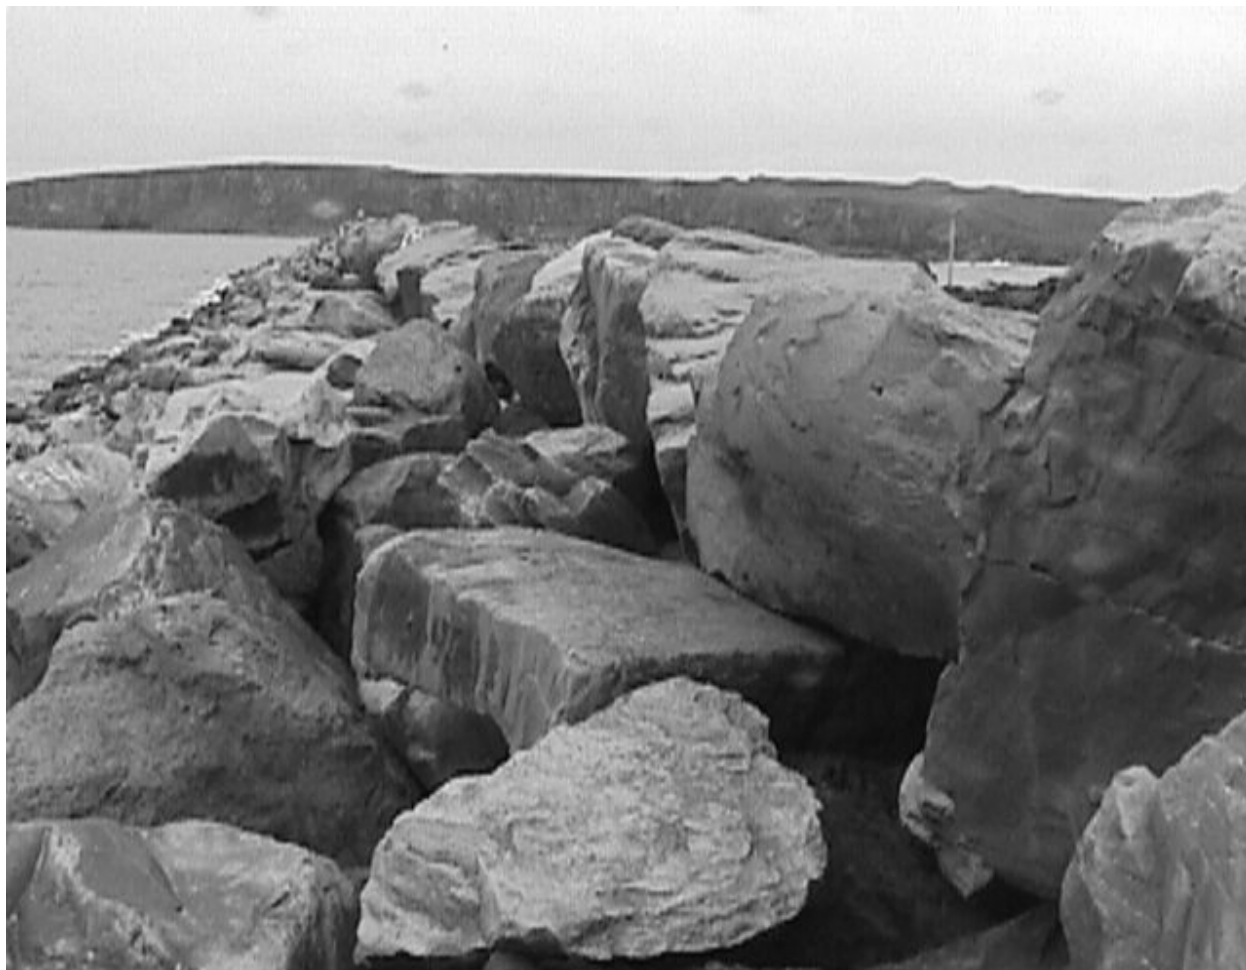
Figure 1. View of St. Paul Harbor breakwater trunk

The initial photogrammetric survey of May 1994 revealed low areas along much of the breakwater. Breakwater topography indicated only about 5 percent of the higher portion of the structure (sta 7+50-15+10) was at its design el +37, and 9 percent of the lower portion (sta 15+10-18+00) was at its design el +30. For the higher portion of the structure, the elevation of about 24 percent of the

length of the breakwater was within 0.3048 m (1 ft) of its design elevation, or between el +36 and el +37; and approximately 66 percent of the structure was between el +35 and el +37, or within 0.6096 m (2 ft) of its design elevation. About 29 percent of the structure length was below el +35. Most of the low area (that below el +35) was concentrated between stas 13+70 and 15+10. For the lower portion of the structure, the elevation of about 50 percent of the length of the breakwater was within 0.3048 m (1 ft) of its design elevation, or between el +29 and el +30; and approximately 89 percent of the structure was within 0.6096 m (2 ft) of its design elevation, or between el +28 and el +30. Only 2 percent of the structure length was below el +28. The initial broken armor unit survey of the St. Paul Harbor breakwater extension occurred during July 1993. The survey revealed 73 broken or cracked armor stones above the waterline. Of the 73 stones, 7 stones were located on the crest, 31 on the seaward slope, and 35 on the harbor side.

The May 1996 photogrammetric survey of the breakwater revealed very slight change in breakwater elevation relative to the 1994 survey. Contours showing the difference in elevations, indicated essentially no change along the crown of the structure. In the vicinity of sta 9+50, a change up to 0.9144 m (3 ft) occurred along the waterline on the sea side of the structure. In this area, however, emergency repairs were made in 1995. Other changes (between 0.3048 and 0.9144 m (1 and 3 ft)) generally occurred on the harbor side of the breakwater. The data indicated essentially no settlement of the structure between 1994 and 1996. Examination of cross section data revealed similar sections for both 1994 and 1996. A broken armor unit survey conducted during June 1996 revealed 230 broken/cracked armor stones on the main breakwater (versus 73 in July 1993). Of the 230 stones, 54 were located on the crest, 105 on the seaward slope, and 71 on the harbor-side slope. Broken stones, generally, were evenly distributed along the length of the structure. The survey indicated that 49 percent of the broken stones were located on the shoreward half of the breakwater extension, and 51 percent on the outer half.

Examination of breakwater topography for the June 2000 photogrammetric survey indicated that essentially no change had occurred in the crest elevation of the breakwater since 1996. Maps developed depicting changes in contours between 1996 and 2000 revealed some areas in the breakwater where voids or subsidence (on the order of 1.5 m (5 ft)) had occurred. Decreases in breakwater elevation were noted along areas on both the seaward and shoreward slopes. Difference contour maps also revealed voids in several areas where single armor stones had been displaced. In addition, breakwater cross sections developed revealed low areas in the structure at some locations. The overall shape and elevation of the breakwater appeared similar, but voids were noted in the 2000 survey that had not been present previously. A broken armor unit survey conducted during July 2000 revealed 221 broken or cracked armor stones above the waterline. Twenty-four new broken stones were noted since the June 1996 inspection, and 33 broken stones documented during the previous inspection could not be found. They could have been moved away by wave and/or ice action. Just fragments of most these stones remained. Of the 221 broken stones identified in the 2000 inspection, 56 were located along the breakwater crest, 96 on the sea-side slope, and 69 on the harbor-side slope. In general, broken stones were evenly distributed along the length of the structure with 54 percent located on the shoreward half of the breakwater extension and 46 percent on the outer half. An obvious void observed during the broken armor unit survey was in a stretch along the waterline on the sea-side slope between stas 8+80 and 9+70 where core stone was exposed in one area. The rate of breakage appeared to have declined at St. Paul breakwater. Only 24 new broken armor stones were observed in the 4-year period between 1996 and 2000 as opposed to 157 broken stones that occurred during the original 3-year monitoring period between 1993 and 1996.

To minimize further breakwater damage and reduce overtopping of the main breakwater, the construction of three submerged reef breakwaters seaward of the structure was completed by the U.S. Army Engineer District, Alaska, during the 2001 construction season. In addition, the void area between stas 8+80 and 9+70 was repaired. The 2000 periodic inspection of the breakwater extension not only determined changes in the armor unit field since previous studies, but established new base conditions since construction of the reef breakwaters. Subsequent inspections will evaluate the effectiveness and analyze the performance of the improved project.

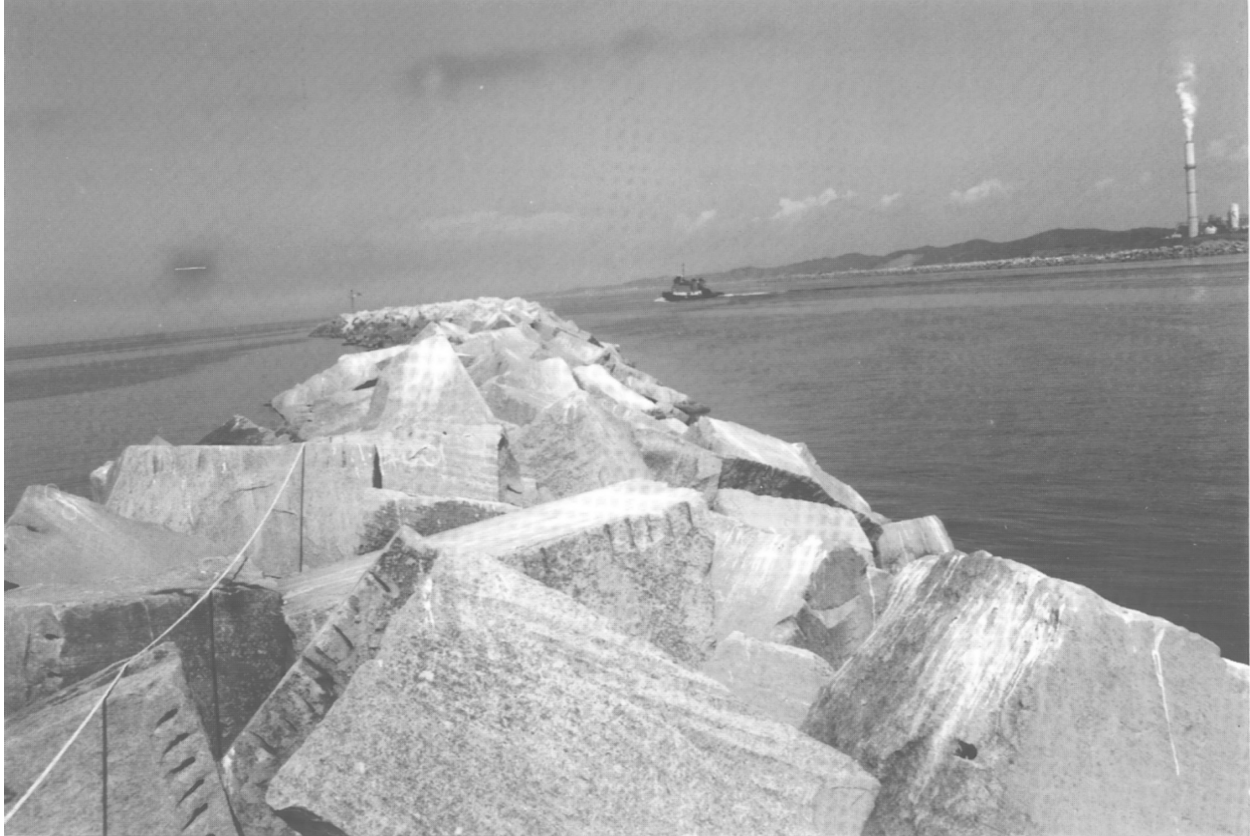
The initial photogrammetric survey of November 1994 revealed low areas along much of the breakwater. Breakwater topography indicated that, cumulatively, about 344.4 m (1,130 ft), or 24 percent, of the total breakwater length was below its design crest el +14. Most of the low areas ranged from el +12 to el +14. Only about 65.5 m (215 ft) cumulative length of the breakwater (4.6 percent) was below el +12. Topography and cross-section data also revealed that the design width of el +17 was not maintained in many areas. In addition, on some portions of the structure, the slope of the harbor side of the breakwater was much steeper than the original 1V:1.5H design. The initial broken armor unit survey of the Burns Harbor north breakwater was conducted during July 1995. The survey revealed a total of 165 broken or cracked armor stones above the waterline. Of the 165 stones, 26 (16 percent) were located on the breakwater crest, 95 (57 percent) on the lake-side slope, and 44 (27 percent) on the harbor-side slope. No broken armor stones were observed around the head. Broken stones occurred along the entire breakwater, however in general, higher concentrations were found along the easternmost portion of the structure. About 50 percent of the broken units were located on the eastern one-third of the breakwater.

Examination of breakwater topography for the July 1999 photogrammetric survey indicated continued loss of structure elevation. Cumulatively, about 646.2 m (2,120 ft), or 46 percent, of the total length of the breakwater was below its design el +14 (versus 24 percent in the previous survey of 1994). About 152.4 m (500 ft) cumulative length of the breakwater (11 percent) was below

Figure 2. View of Burns Harbor north breakwater trunk

el +12 in July 1999 versus 65.5 m (215 ft) (4.6 percent) in July 1994. In July 1999, concentrations of low areas occurred between stas 8+40-15+65 and 30+70-37+80, however, sporadic areas of low elevation were noted along the length of the structure. Both the 1994 and 1999 surveys revealed the crest width less than the el 17 design and steep slopes (steeper than the 1V:1.5H design) on the harbor side of the structure. A broken armor unit survey conducted during July 1999 revealed 225 broken or cracked armor stones above the waterline (versus 165 in July 1995). Of the 225 stones, 34 were located on the breakwater crest, 96 on the lake-side slope, and 95 on the harbor-side slope. About 42 percent of the broken stones were observed on both the lake- and harbor-side slopes in 1999 versus 57 percent on the lake side and 27 percent on the harbor side in 1995. The survey revealed that between 1995 and 1999 most of the additional breakage occurred on the harbor-side slope. The percent of broken armor units on the breakwater crest remained relatively constant at 15 to 16 percent for both surveys. In 1999, about 44 percent of the broken armor stones were located on the eastern one-third of the breakwater versus 50 percent of the broken stones in 1995.

To minimize further breakwater damage and reduce transmitted wave heights in the harbor, a submerged reef breakwater was constructed lakeward of the north structure during the construction seasons between June 1995 and August 1998 by the U.S. Army Engineer District, Chicago. The 1999 periodic inspection of the breakwater not only determined changes in the armor unit field since the previous survey, but established new base conditions since construction of the submerged reef breakwater. Subsequent inspections will evaluate the effectiveness and analyze the performance of the improved project.
